DOT/FAA/AM-04/24  
Office of Aerospace Medicine  
Washington, DC 20591

# A Summary of Unmanned Aircraft Accident/Incident Data: Human Factors Implications

December 2004

Final Report

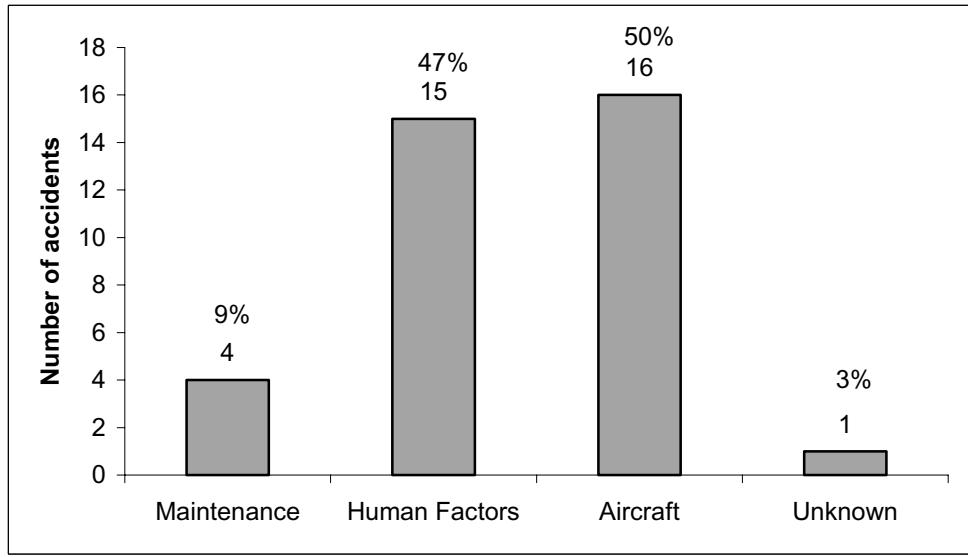
**Figure 3.** U.S. Army Hunter accident causal factors.

Data from the Hunter program indicated that 15 of the 32 accidents (47%) had one or more human factors issues associated with them. Figure 3 shows the major causal categories for Hunter accidents. Note that the percentages add to more than 100% because some of the accidents were classified into more than one category.

By far the largest human factors issue is the difficulty experienced by EPs during landings, with 47% of the human factors-related Hunter accidents occurring during this phase. An additional 20% of the accidents involved an error by the EP during takeoff. Control difficulties are at least partially caused because when the aircraft is approaching the EP, the control inputs to maneuver the aircraft left and right are opposite what they would be when the aircraft is moving away from the EP. This reversed-control problem is present for any UA operated by an external pilot via visual contact. Other research has also identified this problem as an important human factors issue related to UA (Gawron, 1998).

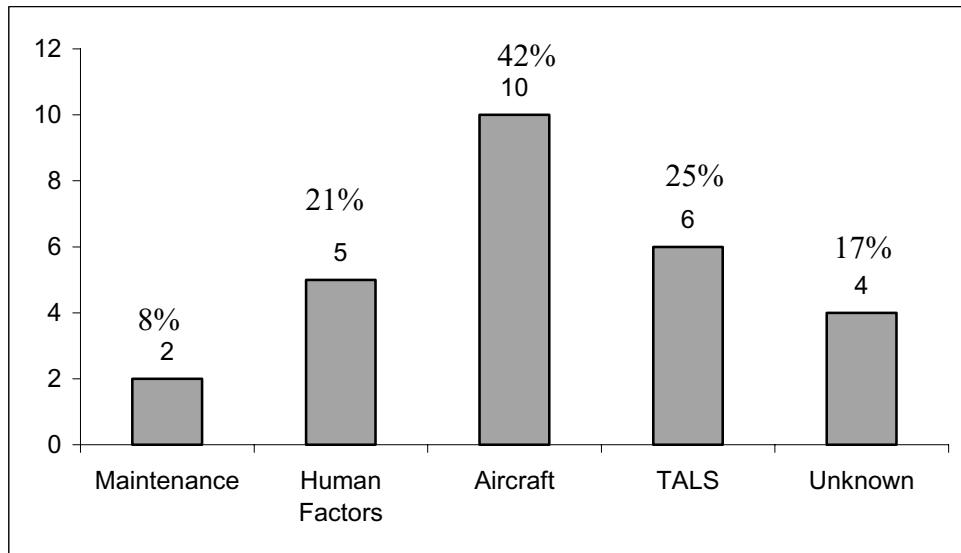
**Figure 5.** U.S. Army Shadow accident causal factors.

The analysis of Shadow accidents shows a different pattern from that seen with the Hunter. In contrast to the Hunter, only 5 of the 24 Shadow accidents (21%) were attributed to human factors issues. Figure 5 shows the major causal factors for the Shadow accidents.

In addition to the four categories used for the Hunter accidents, an additional category was added for Shadow to include failures of the tactical automated landing system. While eliminating landing accidents potentially attributable to an EP, the use of TALS is not perfect, as shown from the data. Use of the launcher eliminated any EP takeoff errors for these aircraft.

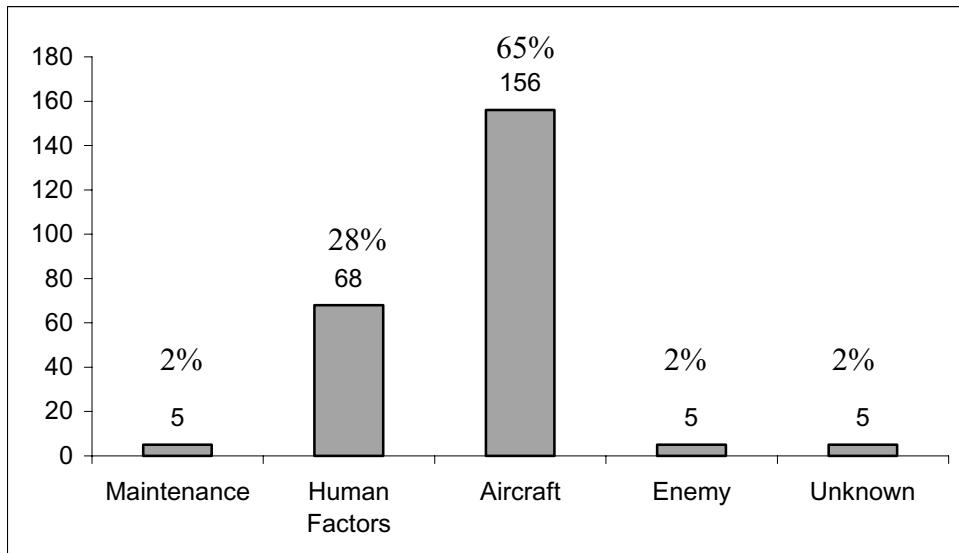
Figure 7. U.S. Navy Pioneer UA accident causal factors.

A list of 239 Pioneer accidents was received from the Navy Safety Center. The accidents cover the period from 1986 until 2002. Although not providing much detail, the data did allow a general categorization of accidents into principal causal categories. Figure 7 shows the major causal factors for Pioneer accidents.

As can be seen from the figure, human factors-related issues were present in approximately 28% of the accidents. Also, a small number of mishaps (5) were attributed to enemy actions. Breaking down the human factors-related accidents further, Table 4 lists the number and percentage of the 68 accidents related to specific human factors issues.

As with the Army Hunter accidents, the largest percentage of human factors accidents (68%) was associated with the difficulty experienced by the EP while landing the aircraft. An additional 10% of the accidents were associated with takeoffs, although the primary means of taking off is through the use of a launcher (from ship-based aircraft). In addition to landing and takeoff errors, two other issues seen with the Pioneer were aircrash

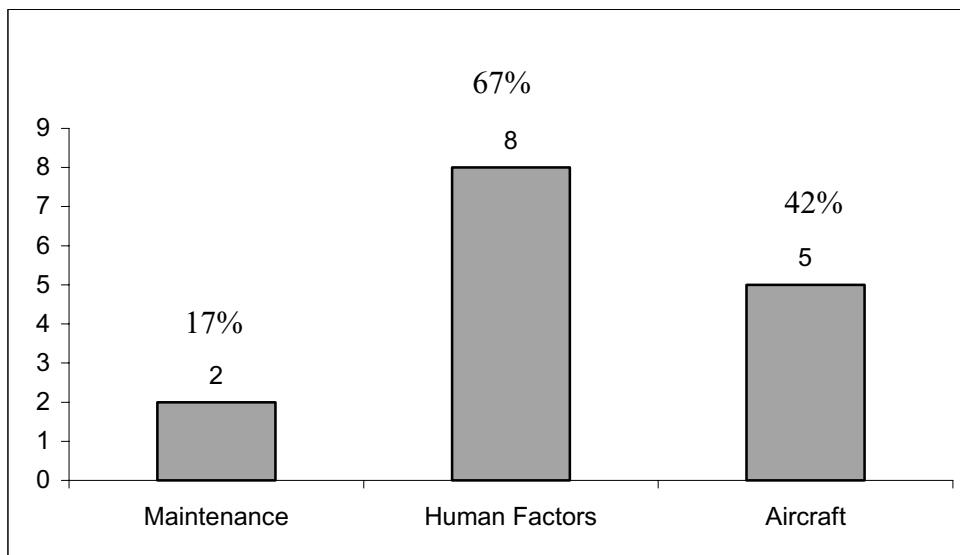
**Figure 12.** Air Force Predator accident causal factors.

The Predator accident causal factors are shown in Figure 12. As can be seen from the figure, human factors encompass a higher percentage (67%) than aircraft-related causes, unlike the other aircraft examined thus far.

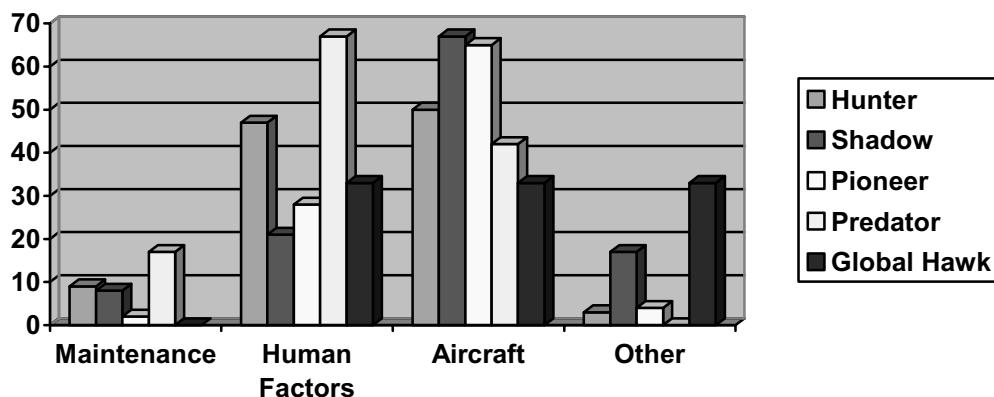
**Figure 14.** Summary accident percentages across aircraft systems.

Figure 14 summarizes the data reported in this report across each UA system. One conclusion apparent from the data reported here is that, for most of the systems examined, electrical and mechanical reliability play as much or more of a role in the accidents as human error. Mishaps attributed at least partially to aircraft failures range from 33% (Global Hawk) to 67% (Shadow) in the data reported here. A recent report by the Office of the Secretary of Defense (Schaefer, 2003) reviewed several factors affecting the electromechanical reliability of UA. The most critical factor cited is that cost savings are more important for UA than for manned aircraft. Unfortunately, cost-saving measures have a tendency to impact component reliability, system redundancy, and the inclusion of new component technologies. For example, cost-saving techniques such as the use of wooden propellers and less attention to watertight sealing leave some UA more vulnerable to precipitation than manned aircraft. In addition, the relatively smaller size of many UA also has an adverse effect on their response to both precipitation and icing. Schaefer points out that “a one-tenth inch accumulation [of ice] on a Pioneer’s wings is equal to one inch on a Boeing 747” (p. 33).
